East Mountain Historical Society

Stone House-Sanchez/Campos – Integrity Report

Overview

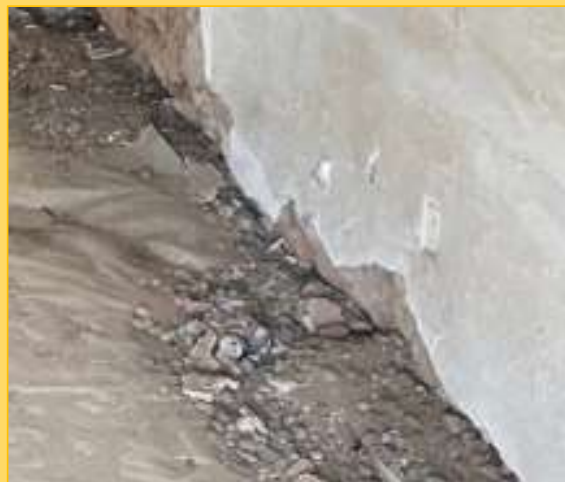
Photos of base of exterior walls, taken from inside of the Stone House. Hand excavation in several locations underneath walls did not discover a foundation

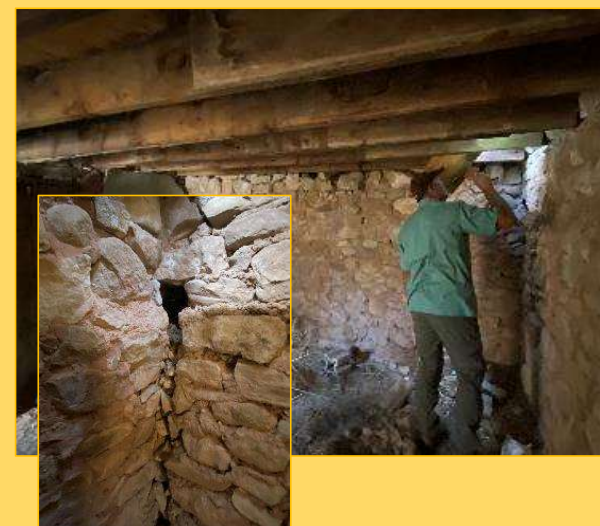
Photos of basement walls which create foundation for some of the walls above. These basement walls appear to be fairly intact and stable.

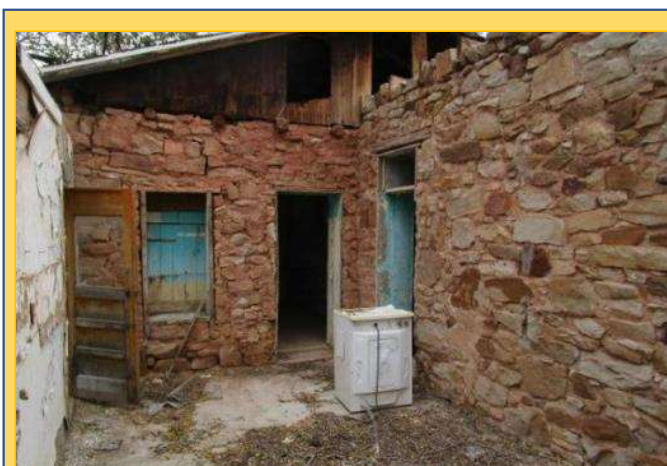
Photos taken inside Main Room (#3). Wall construction rock and lime mortar can be easily seen. Some remnants of adobe/mud plaster remain.

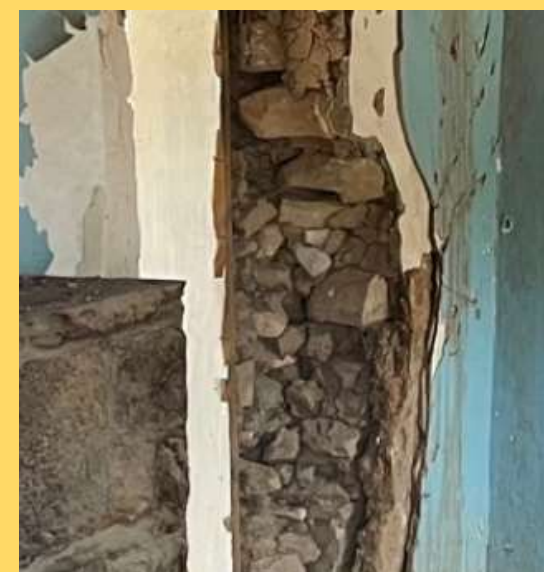
Photos taken inside Back Room (#1). This exposed wall provides a cross sectional view of rock wall construction.

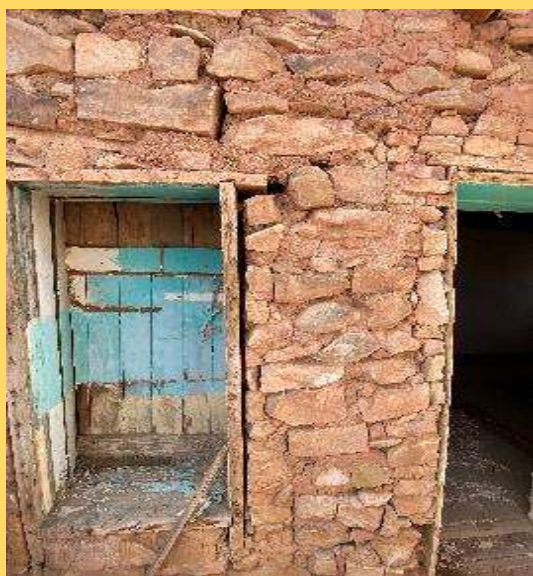
A few cracks in walls were observed near windows or doors. However, no cracks were seen that indicated significant structural shifts.

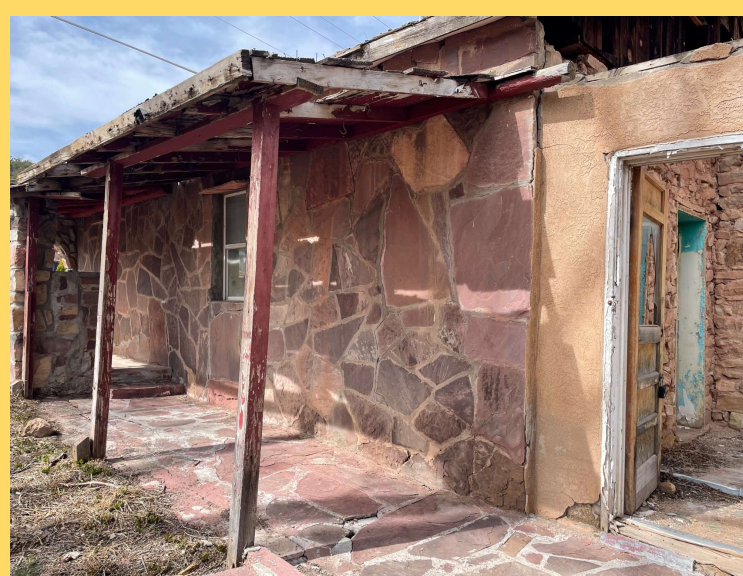
This photo clearly shows the laminated rock covering much of the exterior of the house. Cement stucco covers most of the remainder, possibly applied over an original exterior finish (ex. adobe/mud or lime plaster)

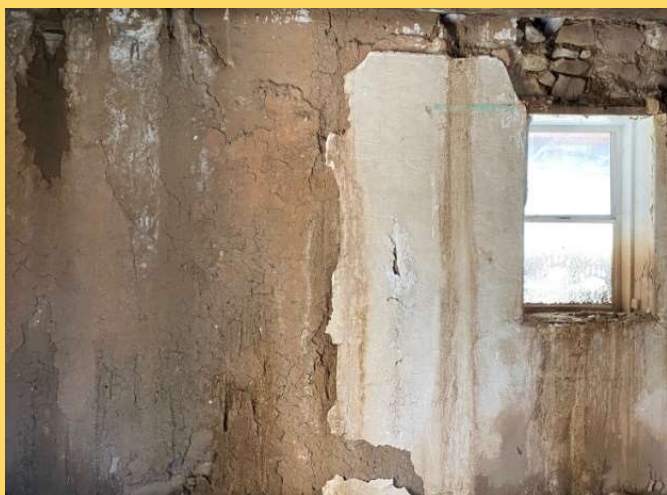
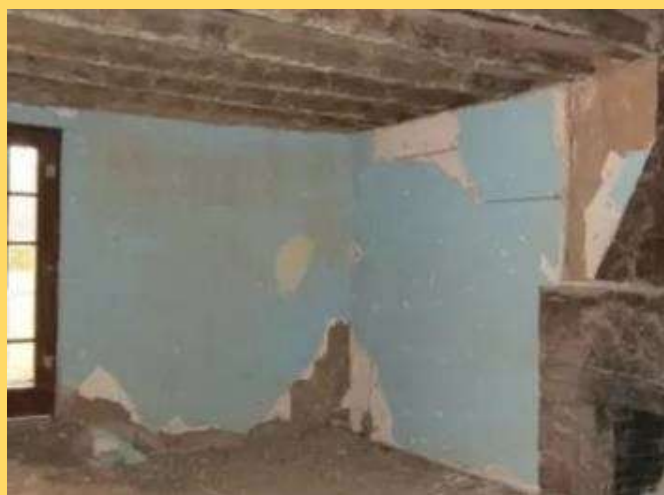
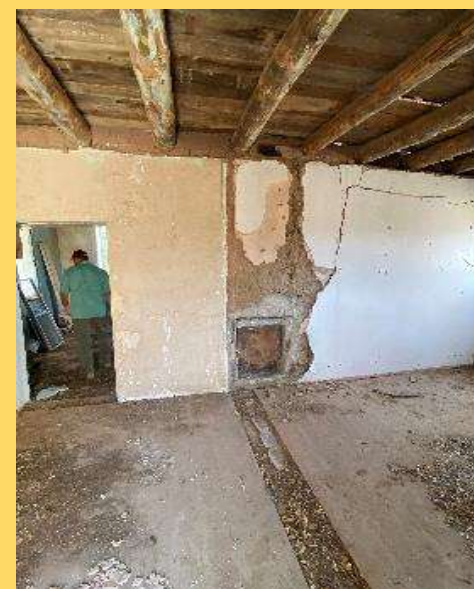
Many of the interior walls were coated with an adobe/mud plaster then washed with what is likely a lime based plaster. Several additional finishes have been applied over time.

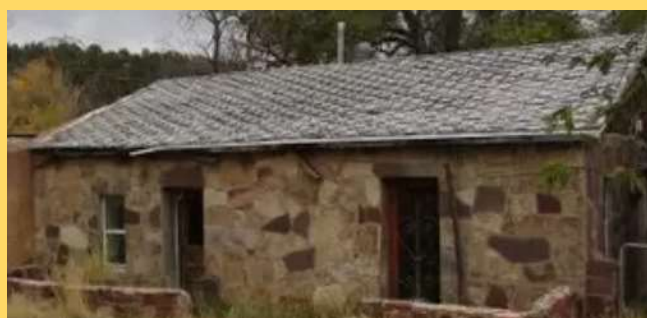
- This pitched roof structure over these rooms is comprised of timbers and round vigas, 1X deck covered with asphalt shingles.
- The roof structure is not typical for modern day construction but appears to be stable.
- There is no obvious sagging in the structure.
- Some minor wood rot was observed in this roof area.
- It is likely some structural shoring and timber replacement will be necessary
- The shingles will need to be replaced.

Photos showing pitched roof over Main Room (#1) and Middle Room (#2)

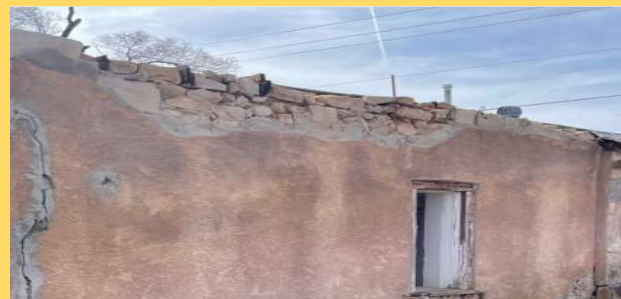
- This flat roof structure over these rooms is comprised of sawn timbers, 1X deck and was most likely some type of composite roof.
- This portion of the house's roof has been compromised for quite some time.

Photos showing flat roof over Back Room (#4) and Bathroom (#5)

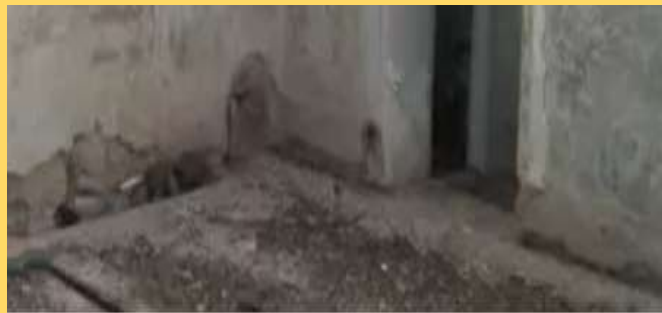
Spongy floor in Back Room #2 and Bathroom (#3)

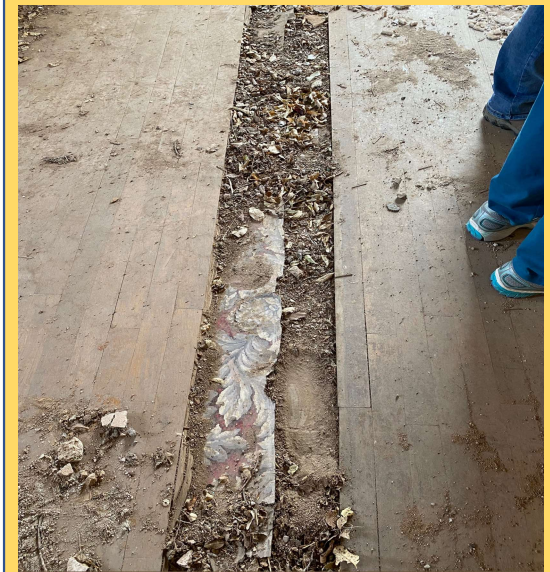
T&G Wood floor in Middle Room (#2)

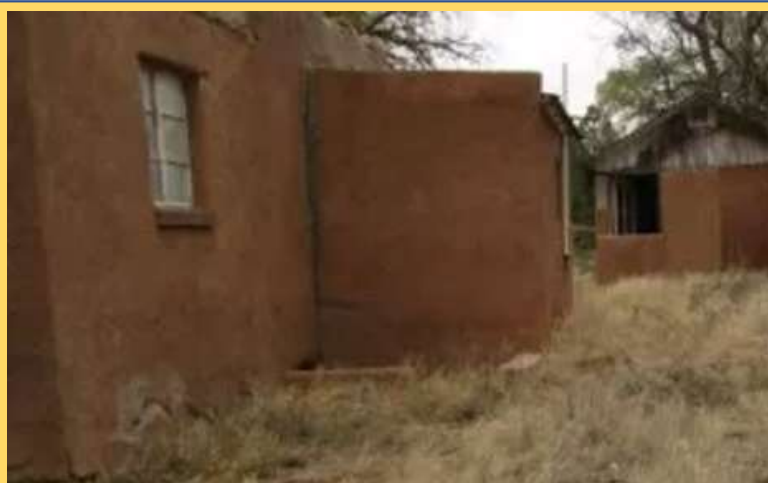
- The bathroom is clearly an addition to the back of the house.
- This bathroom is the only room with any evidence of plumbing fixtures
- It appeared that the fixtures have not been used for a very long time
- The additions building structure appears to be in the worst condition of the entire house and showed evidence of settling and/or structural failure.
- No pictures were taken in this room as there were safety concerns entering this area.
- The team agreed that this room is likely not salvageable.

Bathroom addition

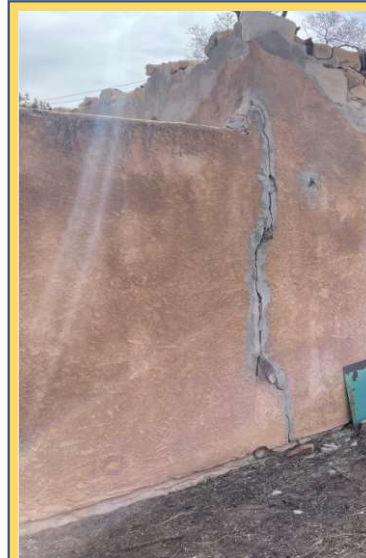
Evidence of settling causing bathroom addition to separate from main structure

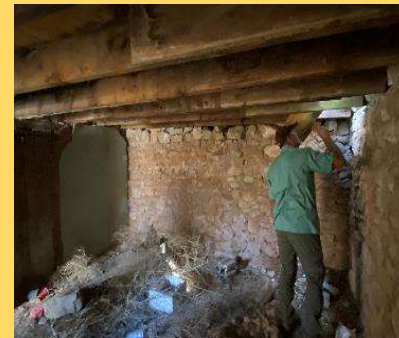
Basement walls are stone and appear to be stable. Some grouting may be required to ensure stability.

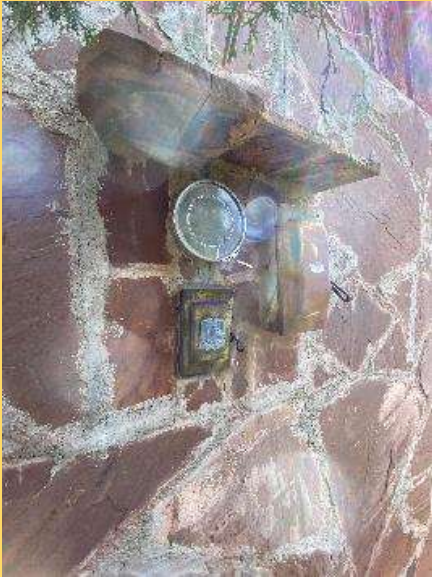
Very little electrical system components remain.

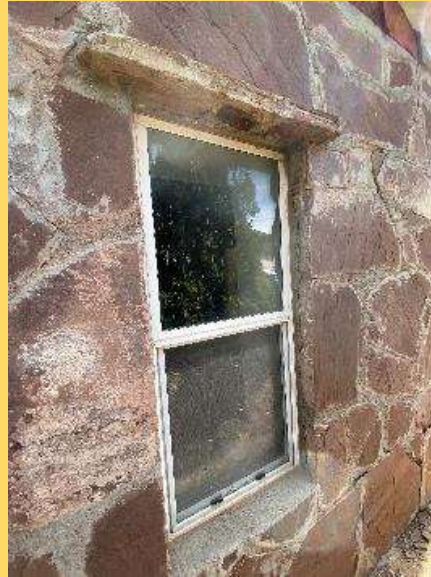
Some windows have been replaced, while some of the old wood frame windows remain.

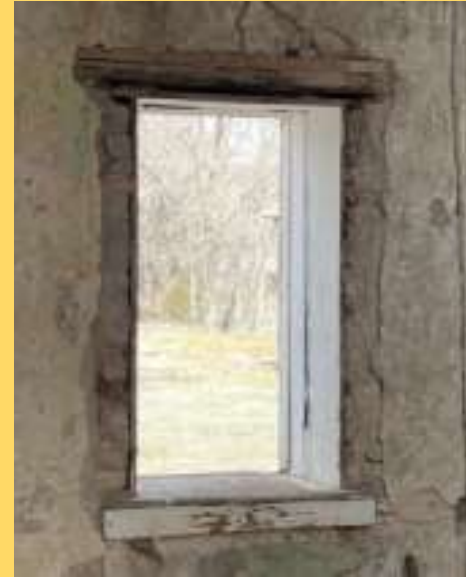
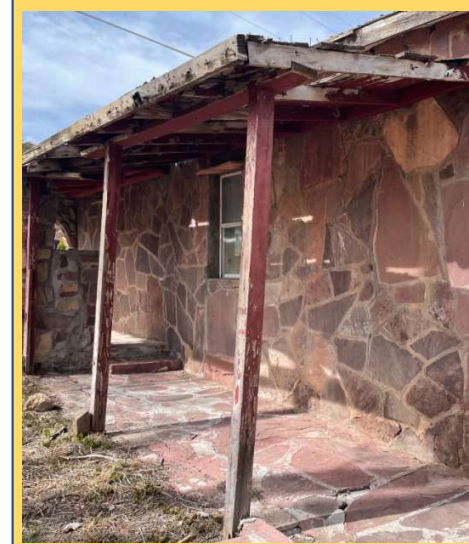
Porch structure is not sound

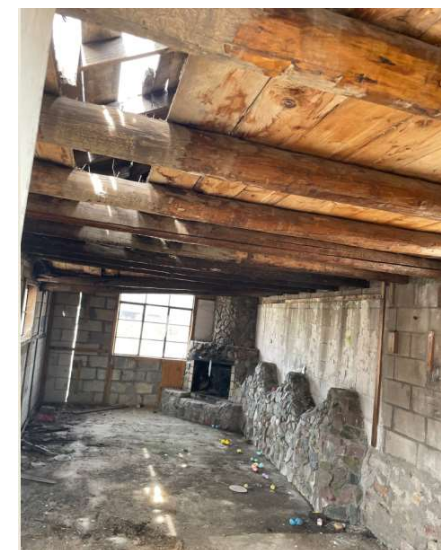
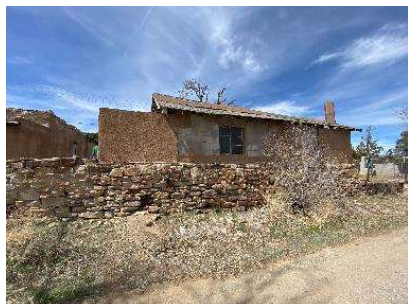
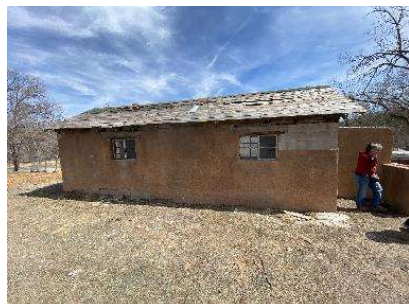
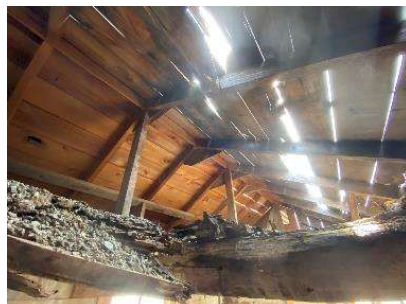
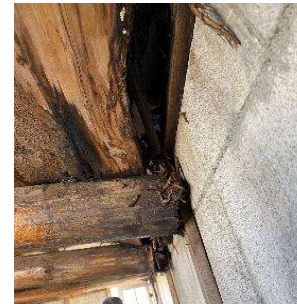
- Detached building located North East of the Stone House
- CMU (cinder block) construction with cement stucco exterior finish
- Roof structure is comprised of round vigas and sawn timber, covered with asphalt shingles
- The floor is a concrete slab.
- Some significant wood rot in the vigas was observed
- A unique interior rock feature exists on the East wall
- A rock fireplace exists in the North East corner
- This was possibly a garage or storage barn at one time
- An approx. 1" wide gap from the floor to ceiling in the North block wall had the team puzzled
