East Mountain Historical Society

Stone House-Sanchez/Campos – Integrity Report

Overview

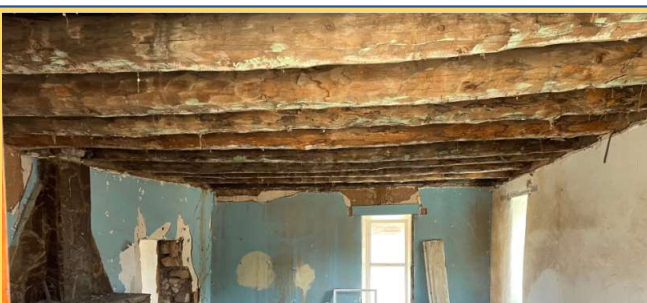
- This pitched roof structure over these rooms is comprised of timbers and round vigas, 1X deck covered with asphalt shingles.
- The roof structure is not typical for modern day construction but appears to be stable.
- There is no obvious sagging in the structure.
- Some minor wood rot was observed in this roof area.
- It is likely some structural shoring and timber replacement will be necessary
- The shingles will need to be replaced.

Round vigas of varying sizes are part of the roof structure.

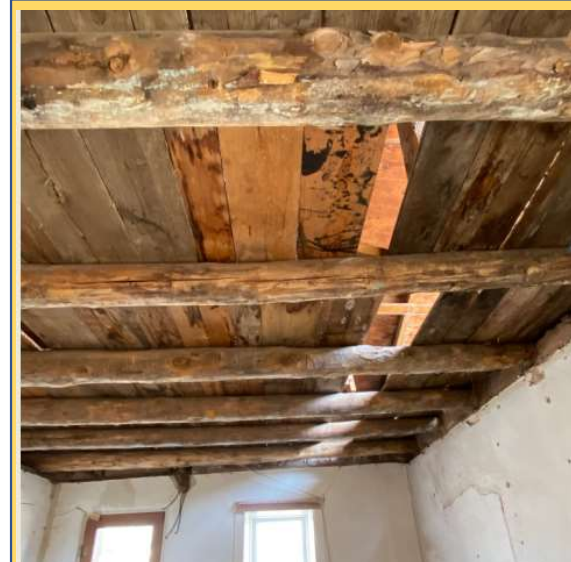
Much of the ceiling has old pine planks above the vigas and timbers.

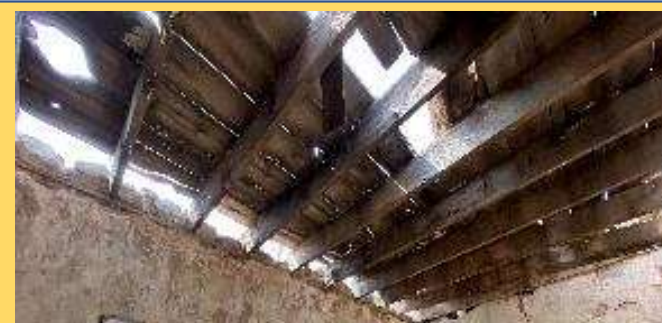
- This flat roof structure over these rooms is comprised of sawn timbers, 1X deck and was most likely some type of composite roof.
- This portion of the house's roof has been compromised for quite some time.

Sawn timbers and 1X comprise the roof structure over these rooms.

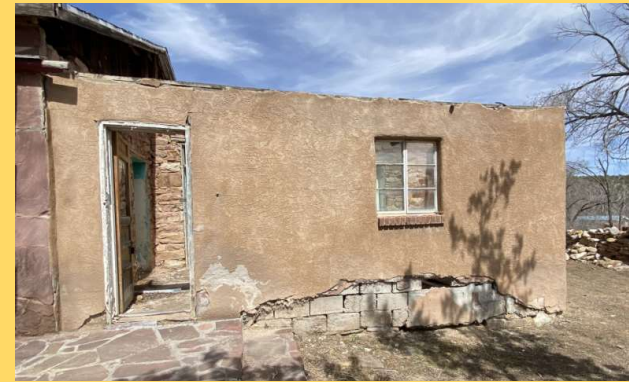
South facing side of Back Room 1 (#3)

- This room is clearly an addition to the house.
- Its South and East walls appear to be CMU (cinder block) construction.
- There has been no roof structure over this room for many years.
- The floor of this room is a concrete slab
- There is an access to the basement in the North East corner of the floor
- The team agreed that this room is likely not salvageable.
- The space and concrete floor in this area potentially provides for a hard surfaced outdoor gathering area or covered patio.

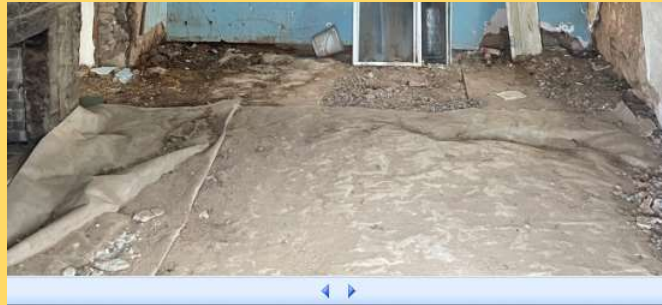
- The entire floor has been removed from the Main Room (#1) and a plastic sheet lies upon the dirt.
- There is evidence of a T&G wood floor (probably pine) in the Middle Room (#2). There are some boards missing but could likely be repaired.
- The floor in Back Room (#2) and Bathroom (#3) is wood sheeting over timber framing and is above the basement. This floor is fairly “spongy” and would require structural work.
- The floor in Back Room (#4) is concrete with an access to the basement in the NE corner.

Plastic covers the dirt in Main Room (#1)

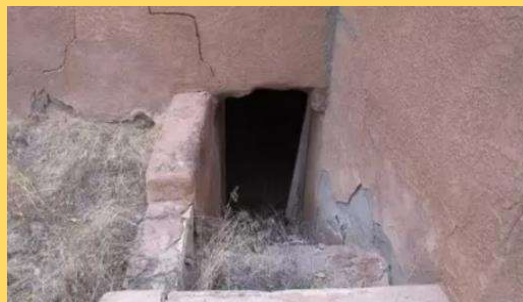
A steep set of exterior stairs lead down to the basement entrance

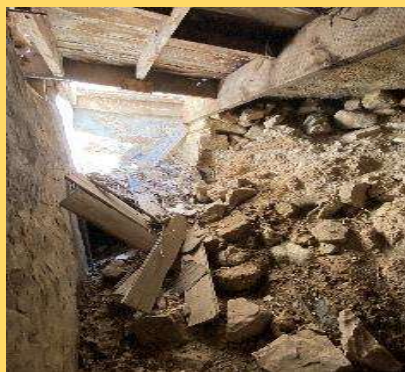
- The basement is located below Back Room 2 (#4) and a portion of Back Room 1 (#3).
- There is an entrance to the basement on the East end of the house.
- The basement floor is dirt.
- An opening in the concrete floor in the North East corner of Back Room 1 (#3) that drops into the basement. A steep and rubble filled “chute” provided another basement access.

A chute from the room above

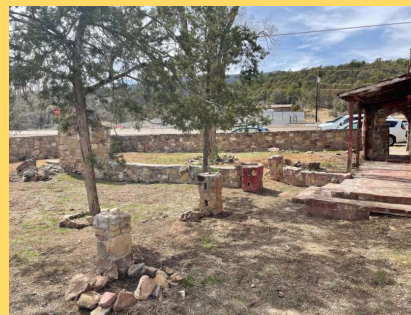
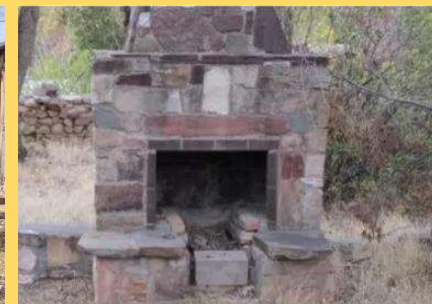
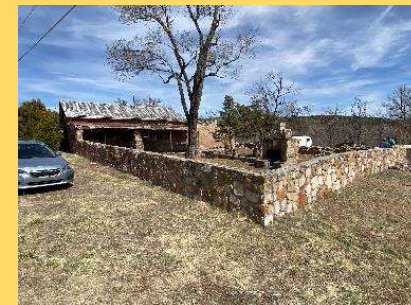
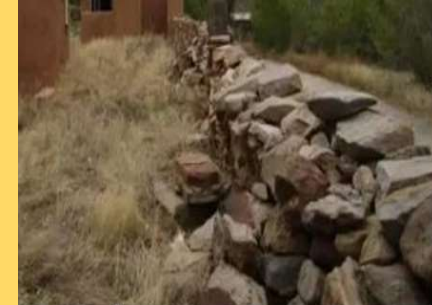
- The area is surrounded by beautiful stacked stone walls. Some of these walls require some restacking and grouting
- A standalone outdoor fireplace is a centerpiece to the area
- With some demolition and renovation, the room in the South West corner offers further outdoor space opportunity.
- Cleanup and some grading is needed
- A thorough review from a safety perspective should be conducted

The area south of the Stone House offer ample opportunity for outdoor gatherings
